**DEPARTMENT OF DEFENCE  
DEFENCE SCIENCE AND TECHNOLOGY ORGANISATION  
AERONAUTICAL RESEARCH LABORATORIES**

**STRUCTURES REPORT 389**

**BRITTLE FRACTURE OF CRASH HELMETS**

FEBRUARY, 1982

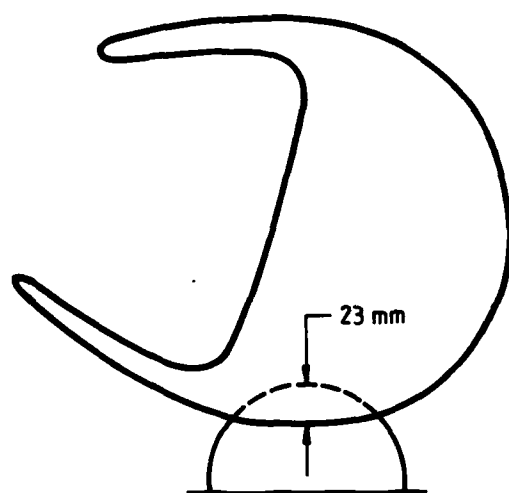
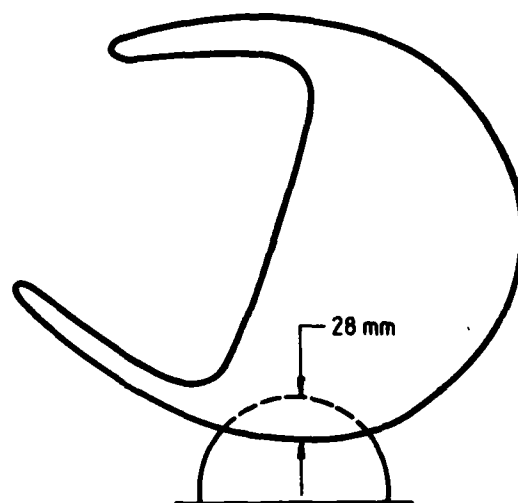
FIG. 3 PROFILE OF HELMET AT LOWEST POSITION DURING IMPACT ONTO  
HEMISPHERICAL ANVIL (from high speed film)

All the helmets withstood the conventional tests (i.e. AS1698 and Snell 1975 spherical anvil impacts) without failure. The surfaces of the fibreglass shells were cracked at the impact site but the polycarbonate shells did not show any damage. The deceleration of the head form was measured in some tests and was about 130 g in all of these. High speed films of selected impacts showed that the polycarbonate and fibreglass shells deflected by about the same amount as shown in Figure 3.

Polycarbonate helmet

Fibreglass helmet

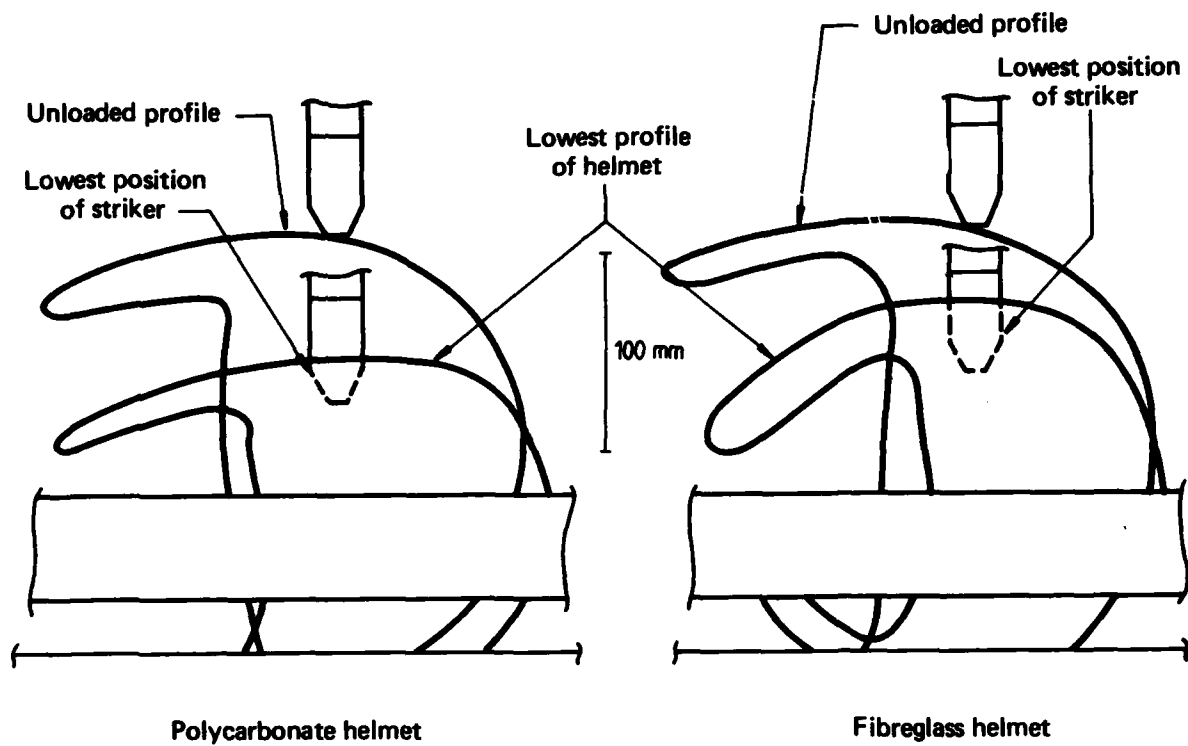
**FIG. 4 PROFILE OF SHELL DURING HIGH SPEED IMPACT TEST  
ON AN EMPTY HELMET (from high speed film) Velocity: 16 m/s  
Helmet tested as received.**

With the new impact test on empty helmets the deflection was extreme, as shown in Figure 4. Several new polycarbonate helmets withstood repeated impacts without fracture, one polycarbonate helmet cracked at a maximum sideways compression of 86 mm at the striker. The crack ran along pre-existing scratches as shown in Figure 5. In another test, an old, used helmet broke on the side away from the striker. The only fibreglass helmet in this group tested was penetrated by the striker to a depth of 83 mm below the original surface. This is shown in Figure 4, the position of the striker within the helmet was deduced from the part of the striker which was visible.

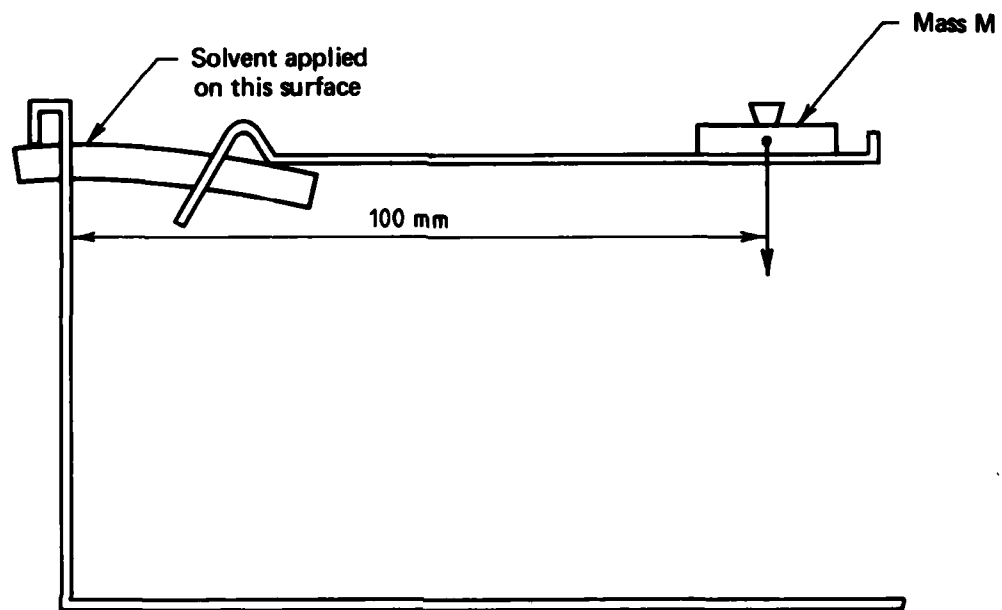
**FIG. 10 BENDING RIG**  
(Stress  $\approx 4.7$  MPa per 100 gm for typical specimen)

To stress them they were placed in a bending rig as shown in Figure 10. They were then moistened with a solvent, either ASTM standard fuel "C" or "super" grade petrol.

mately 50 MPa. Consistent brittle failure with low energy absorption occurred with a stressing mass of 30 gm, giving 1.4 MPa, i.e., only 3% of the stress that the material could support.
